Service Bulletin

BULLETIN NUMBER CSSB-002 **DATE** 21.08.02 Page 1 of 2

SUBJECT Silencer rivet and Operators Manual amendment.

ENGINES AFFECTED Cors-Air engines, all serial numbers with old style silencer (pre August 2002).

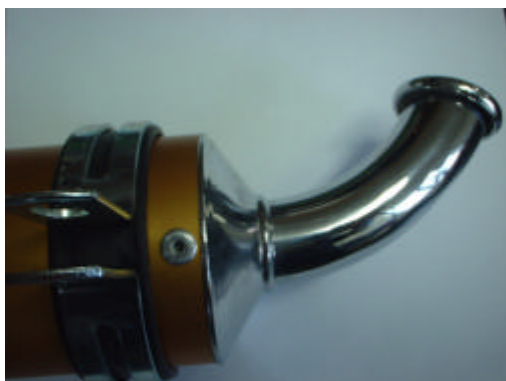
Figure 1.

The rear most bent section of the silencer on one Cors-Air engine has turned towards the pilot's harness during flight, causing a 20cm burn on the harness. This is believed to be the result of the loss of part of the silencer wadding which had held the bent section in place.

The bent section must be riveted in place using a STAINLESS STEEL rivet.

Fit a STAINLESS STEEL rivet to the old style silencer located in the position as shown in figure 1.
