Service Bulletin

BULLETIN NUMBER CSSB-004 **DATE** 1.08.05 Page 1 of 2

SUBJECT Silencer Rivet.

ENGINES AFFECTED ALL Cors-Air engines, all M21Y and M25 Black Devil engines.

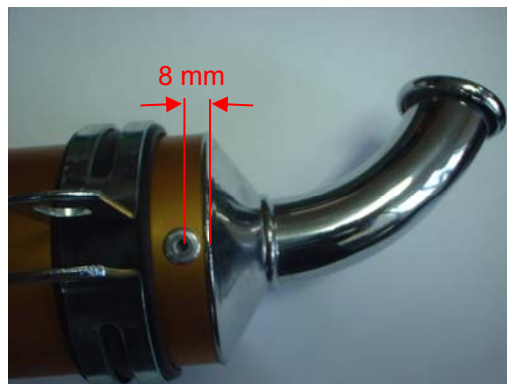
Figure 1.

The rear most bent section of the silencer on a Cors-Air engine has turned towards the pilot's harness during flight, causing a burn on the harness and melting the top of the fuel tank. This is as a result of the muffler rivet falling out or sheering.

This is the first failure of this nature with the correct stainless steel rivet fitted. You must ensure that you do not fit any other type of rivet as they may not be strong enough.

The bent section must be riveted in place using 2 x 5mm STAINLESS STEEL rivets 180° apart.

Fit 2 x 5mm STAINLESS STEEL rivets to the old style silencer, one must be located in the position as shown in figure 1, and the other rivet must be installed directly opposite (180°)
